WATER BOARD FIELD OBSERVATION SUMMARY FOR OCTOBER 13, 2016

Prepared by Taylor Zentner, Engineering Geologist, Lahontan Regional Water Quality Control Board (Water Board), November 21, 2016.

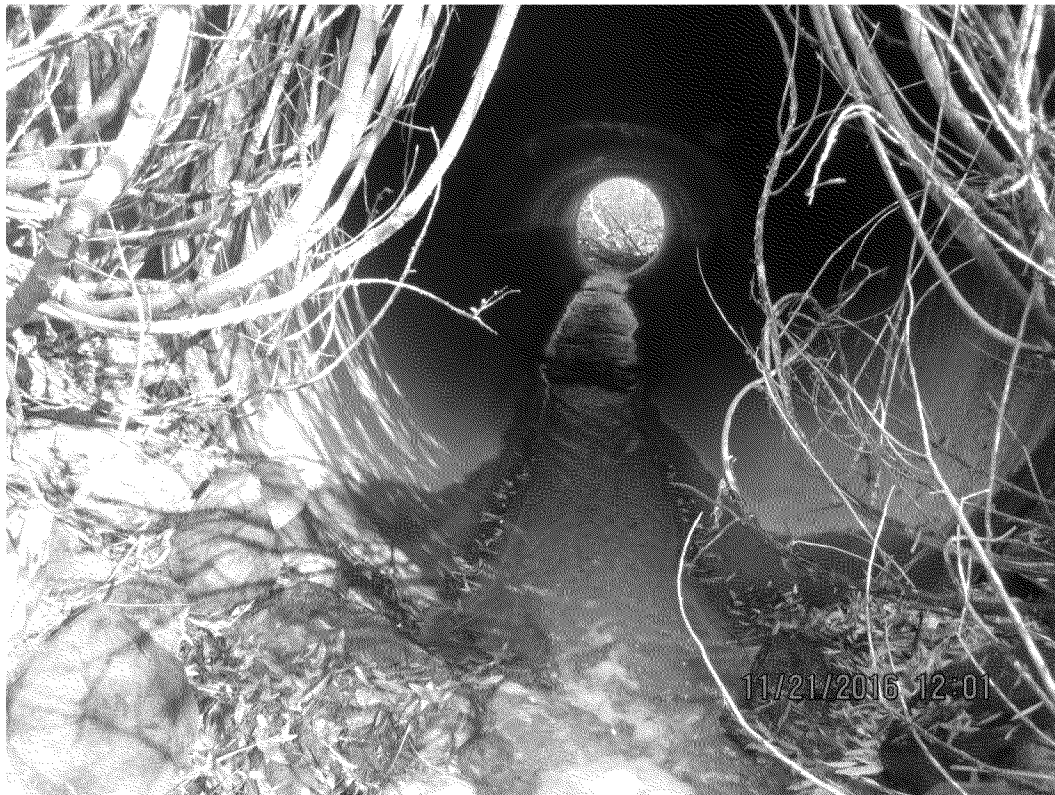
Water Board personnel stopped at the culvert that conveys Leviathan Creek under USFS Road 31052 immediately downstream of the confluence of Leviathan and Aspen Creeks. The culvert appears to be functioning properly. See Photos 1 and 2 for conditions observed at the culvert. Please note that the time stamp in all of the photos in this Field Observation Summary is one hour fast. For example, the time shown in Photo 1 is 12:01, the actual time was 11:01. This issue will be corrected in the future.

Photo 1 – Upstream end of culvert looking downstream

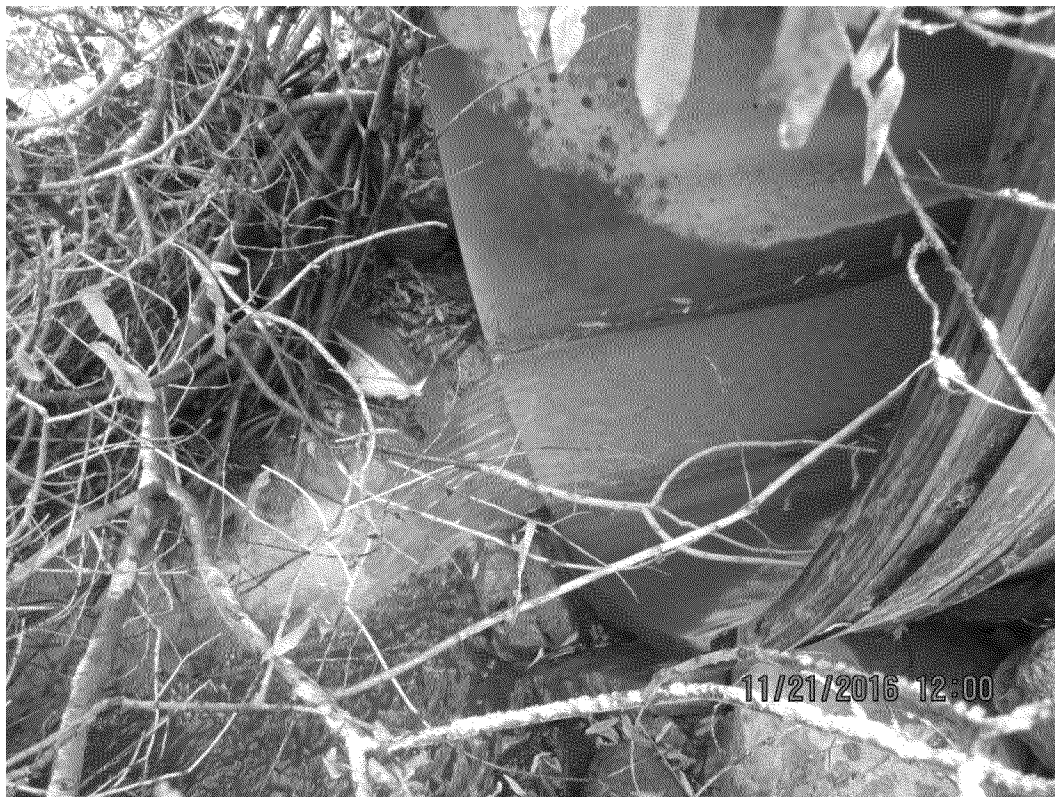
Photo 2 – Downstream end of culvert

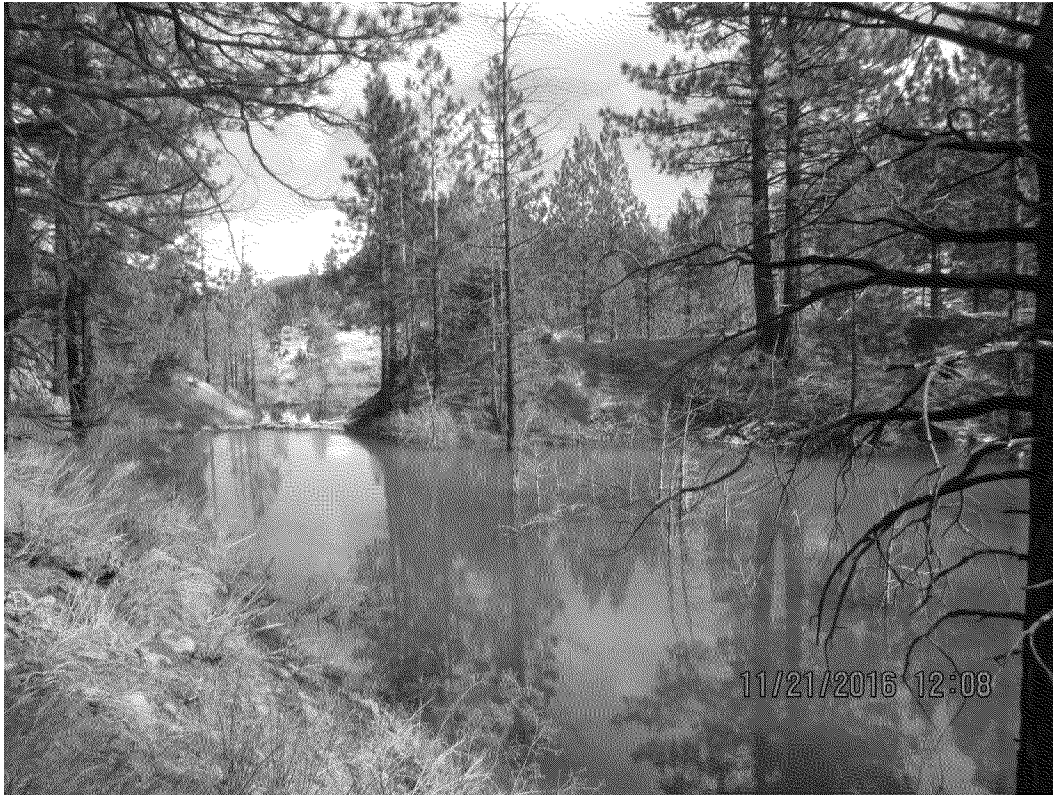
Water Board personnel also observed the beaver ponds. The ponds are mostly full and intact. See Photo 3.

Photo 3 – Beaver pond immediately upstream from the old haul road, looking downstream

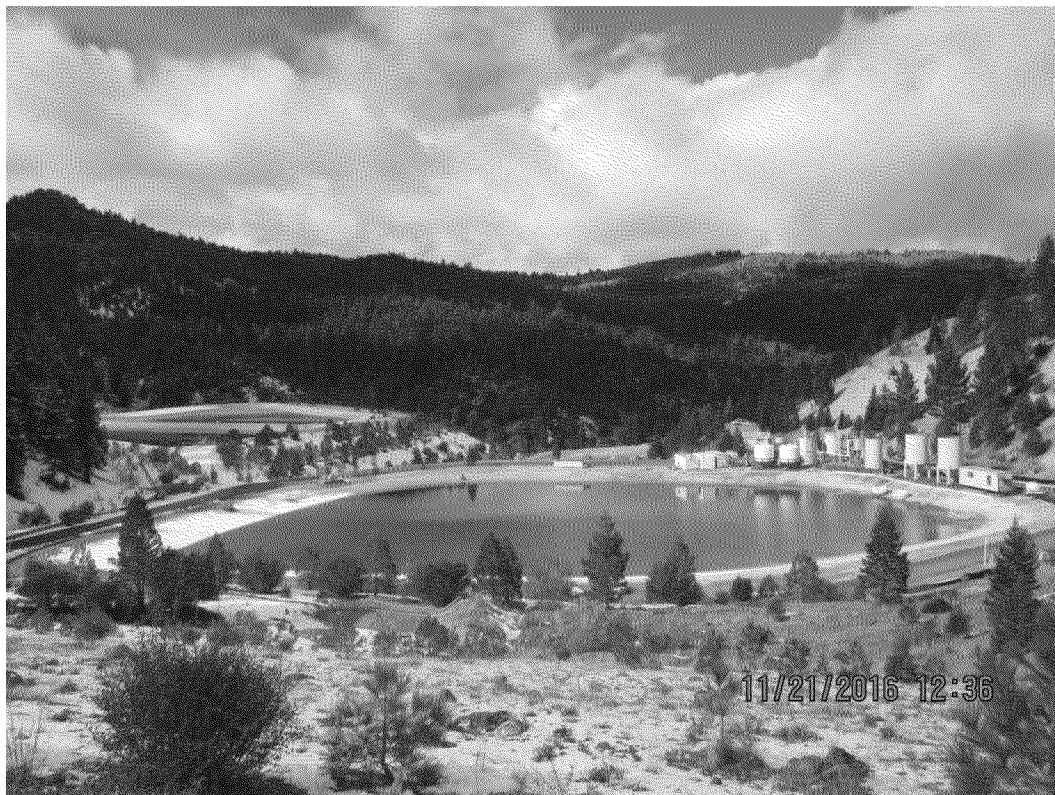
Onsite areas were mostly clear with less than one-inch of snow on some north facing slopes. The water level in Ponds 1, 2 North, and 2 South are all well below the overflow structures. No Atlantic Richfield contractors or subcontractors were observed on site. Water Board staff looked in and around the Flow Control Structure which appeared to be functioning properly. See Photos 4-6 for general site conditions.

Photo 4 – Pond 1 in the foreground and Ponds 2 North and 2 South in the background

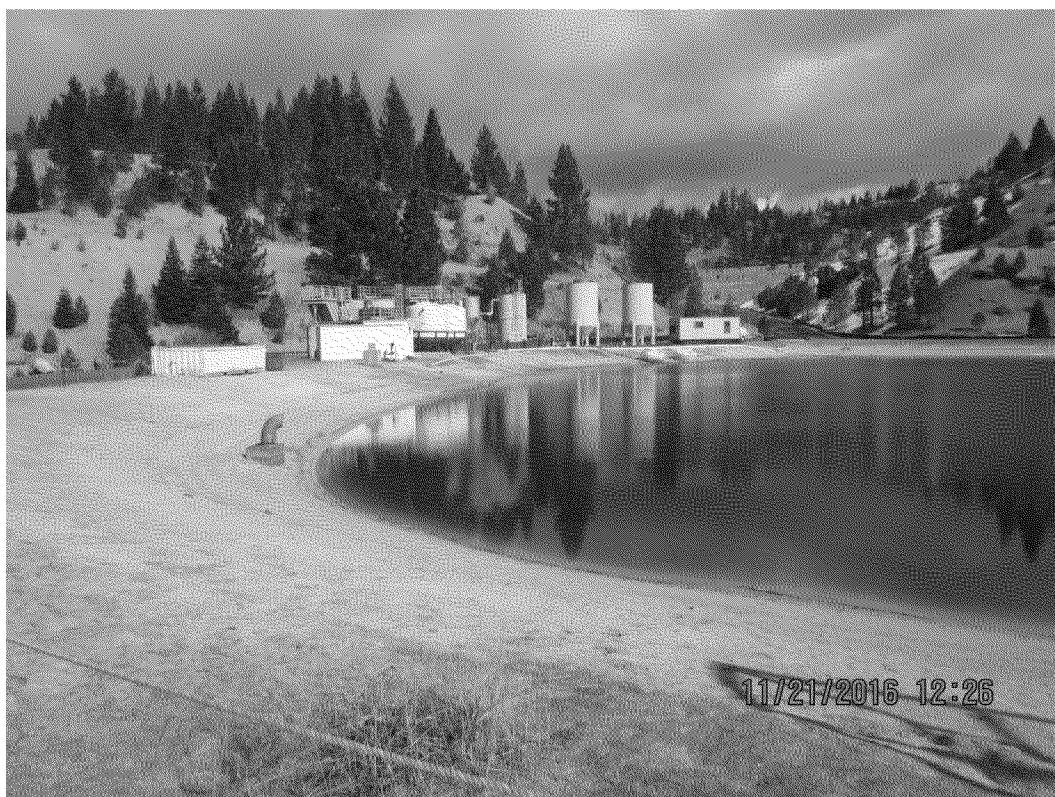
Photo 5 – Pond 1, the water level in Pond 1 is well below the overflow structure

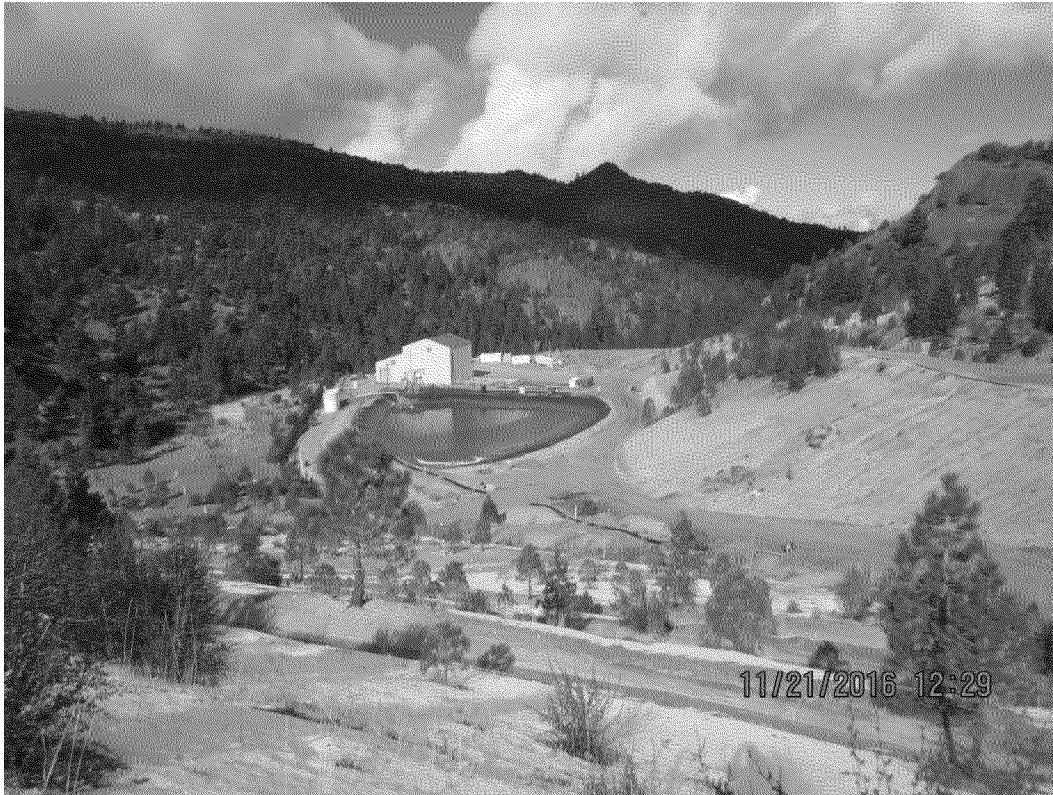
Photo 6 – Looking from Pond 2 North towards Pond 4 and the HDS plant
